Stability of Alhambra Creek at the John Muir Gravesite

John Muir National Historic Site

Technical Report NPS/NRWRD/NRTR-2002/297

April 2002

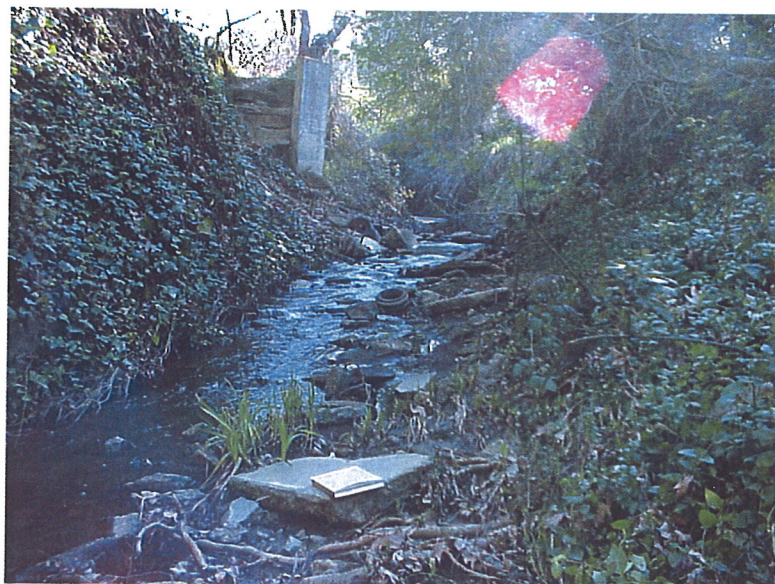
*Figure 3. Alhambra Creek, looking upstream at bridge abutments and concrete rubble
(NPS, February 2002)*

concrete rubble in Alhambra Creek opposite of the gravesite on private property. It is a violation of County ordinances, as well as State and Federal laws, to build in the channel without a permit. The presence of this rubble blocking and/or diverting flows in the channel has serious consequences for the stability of the gravesite.

Channel blockage from the artificial rubble and the existing, but poorly designed, bank protection on the opposite side are likely causing undercutting of the bank near the gravesite. The rubble and blockage on the opposite side should be removed and replaced with a properly designed toe protection structure on both sides of the channel. The challenge will be to get the machinery and materials down into the channel without damaging the trees and their root structure, thus inadvertently destabilizing the bank. More natural appearing rock, instead of concrete rubble, will improve the aesthetics of the area. The toe structure should be designed to prevent channel movement to at least bankfull flows, possibly higher to a 5 or 10-year flow without changing the hydraulics or pre-rubble channel capacity. This may require negotiations with the private property owner to allow the NPS to help manage the stability of their side of Alhambra Creek.

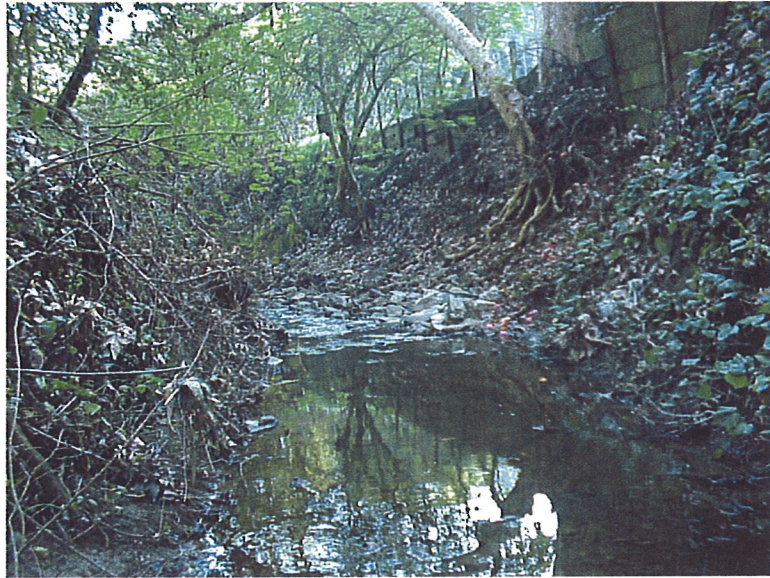
*Figure 4. Alhambra Creek, looking downstream (northeast) from below the gravesite
(NPS, February 2002)*

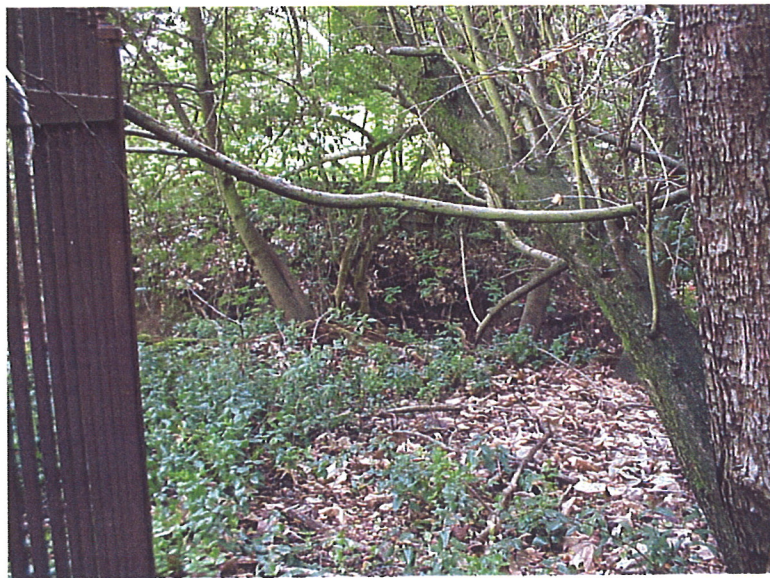
*Figure 5. Looking east at Alhambra Creek from the southeast corner of the gravesite
(NPS, March 2000)*

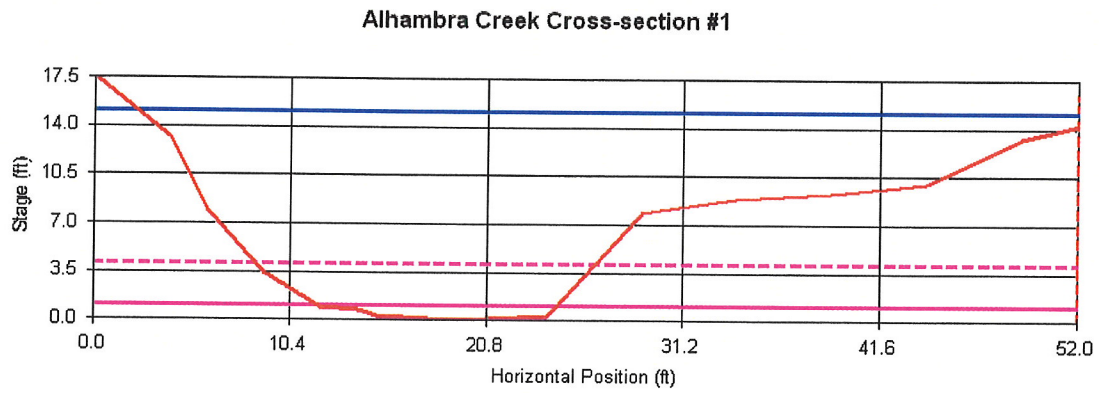
Figure 6. Upstream cross-section plot with a clear channel (WinXSPRO)

Clear Channel

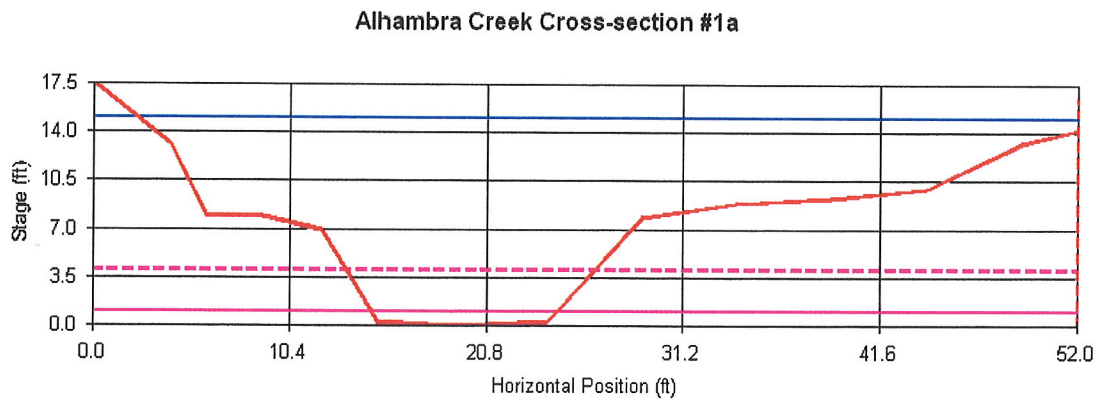
Figure 6a. Upstream cross-section plot with rubble bank protection (WinXSPRO)

Includes rubble bank protection

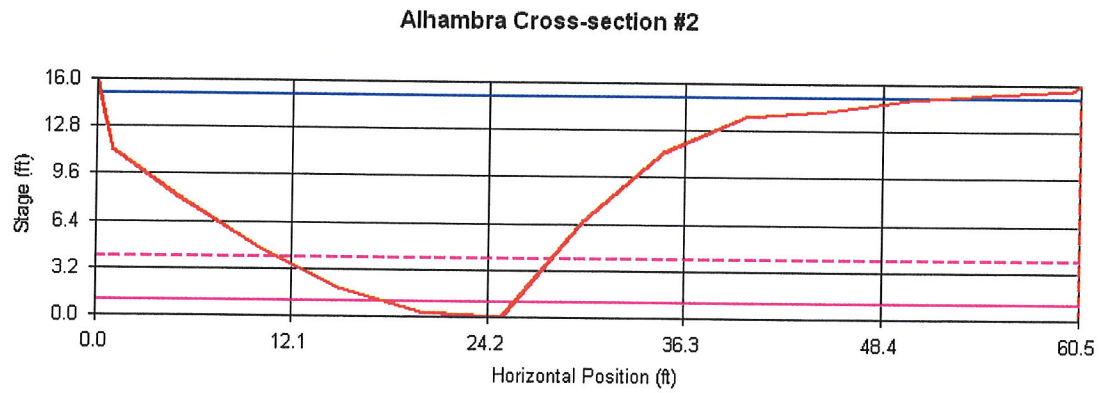
Figure 7. Plot of cross-section opposite the gravesite (WinXSPRO)

Adjacent to gravesite

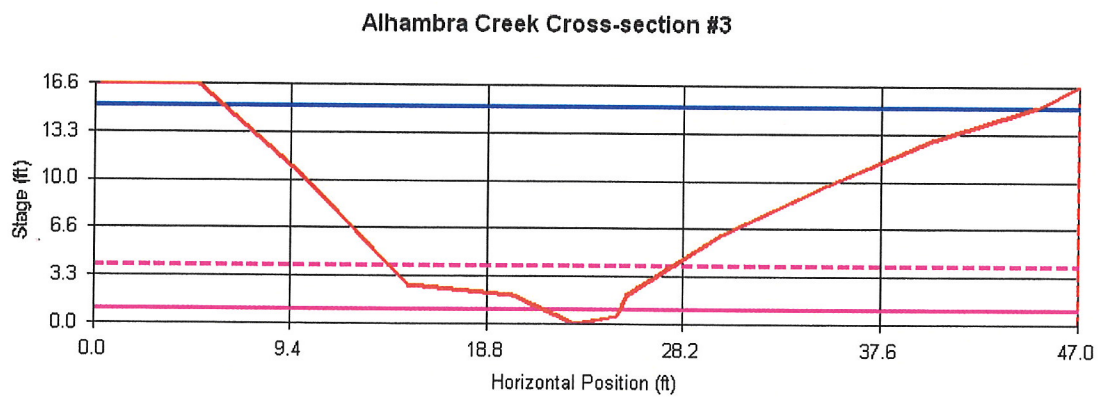
Figure 8. Downstream cross-section plot (WinXSPRO)

Near Strenzel Lane Outfall

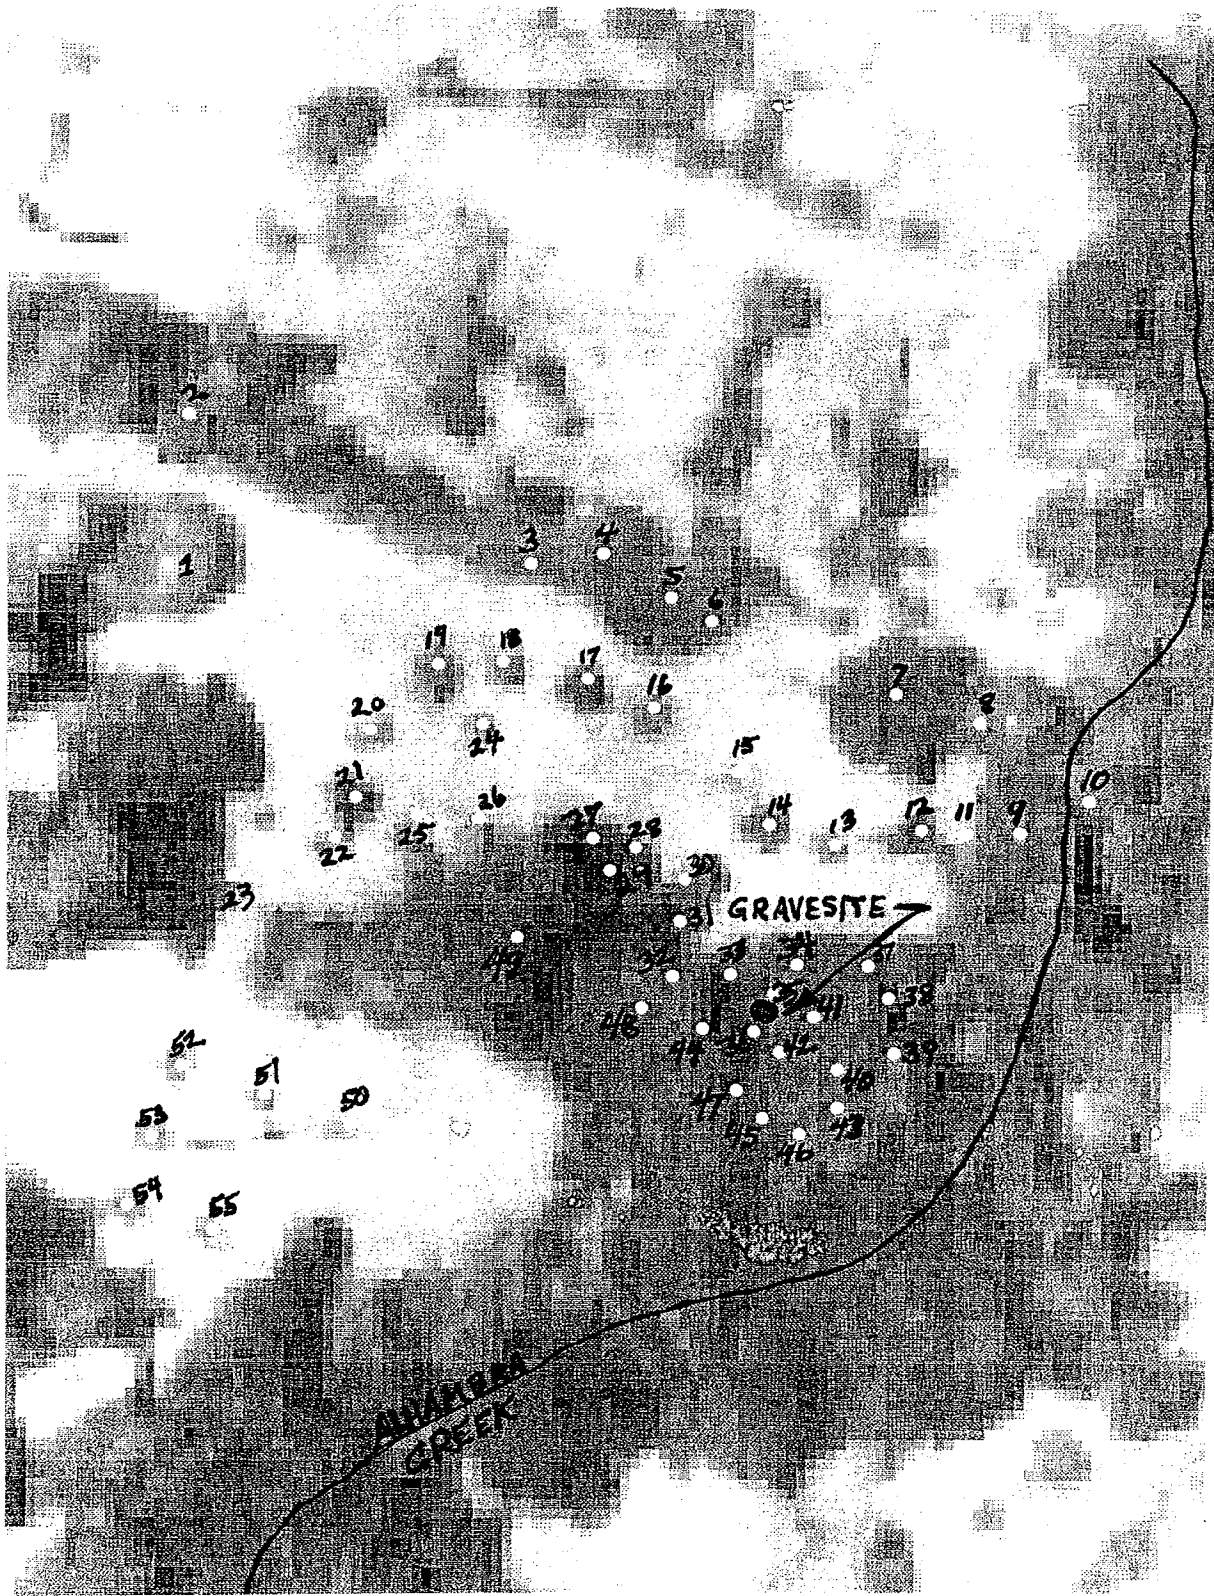
Figure 9. Inventory of tree species near gravesite (NPS, 2002)

Vegetation - A deciduous forest (sycamores and California buckeye) with many exotic trees (eucalyptus and Ponderosa Pine) dominates the riparian zone. See Figure 9 and Table 1 for an inventory of the trees conducted by park staff. The under story is composed of a few shrubs and exotic vines. Many roots from woody species are exposed on the surface of the bank (most of them still alive). A few herbaceous plants grow in the channel.

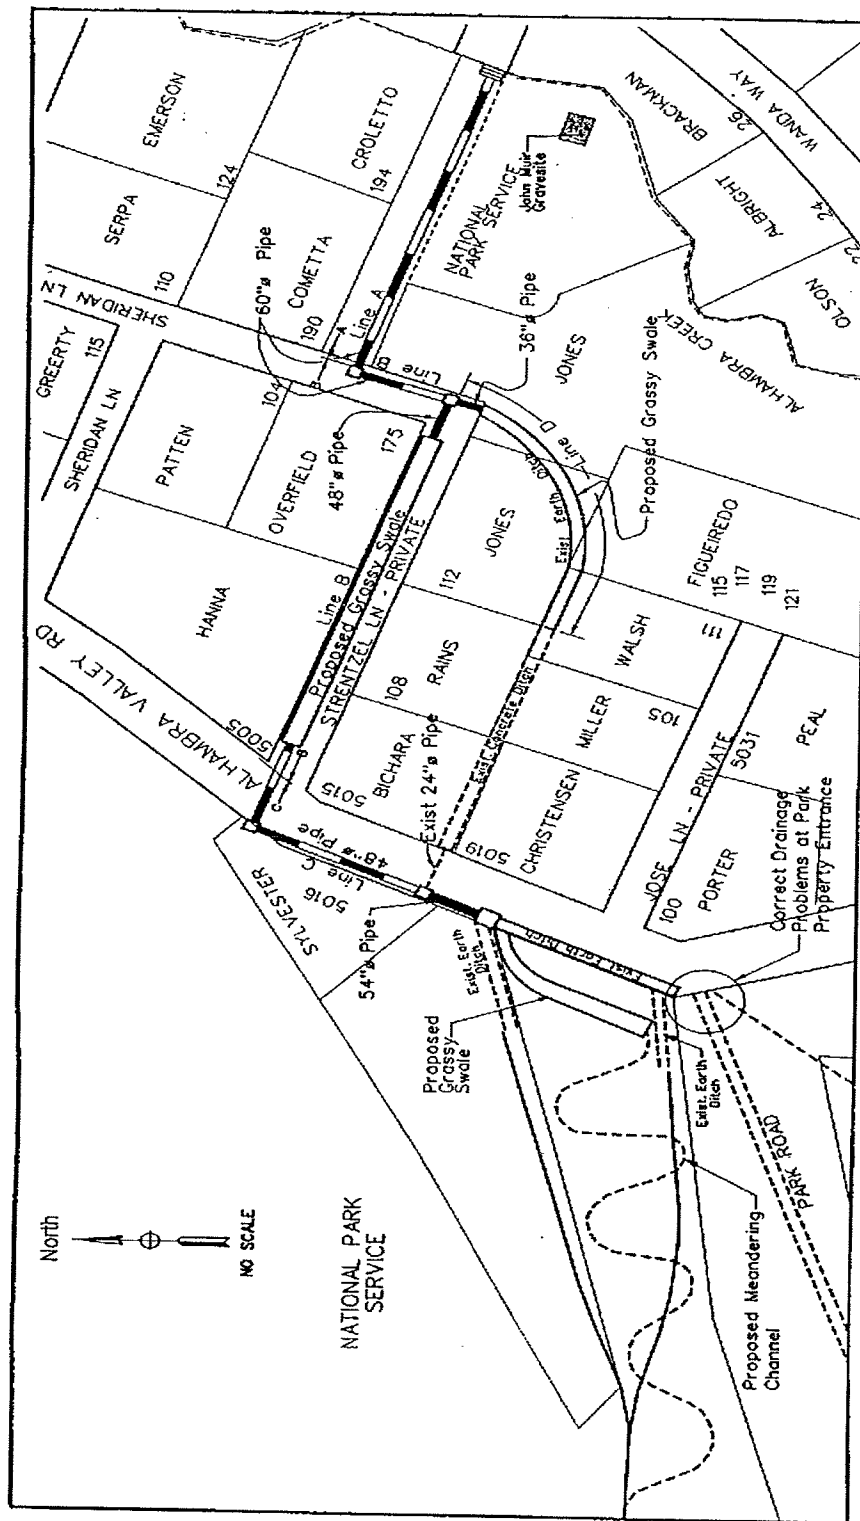
Figure 10. Property map and proposed storm drain
(Contra Costa County Flood Control District, 1999)

Existing Structures – Abandoned bridge abutments exist about 150' downstream from the gravesite. Bank protection works are scattered throughout the reach. The channel is completely lined by concrete about 500' upstream from the gravesite along the entire length of an upstream property. The recently constructed, concrete rubble wall across from the gravesite obstructs flow in the channel by about 25%. See Figures 6 and 6a for the difference in the area of the cross-section. The proposed storm drain is to be built downstream, possibly replacing the abandoned bridge abutments. See Figure 10 for the configuration of the storm drain.
